**Flood Control Project Maintenance  
Levee Inspections**

**Maintenance Issue Types Only, Levee Inspection Report By Mile - Fall 2016**

**Reclamation District No. 0010 Honcut**

Waterway	Bank	Unit Miles	Inspection Start/End	Inspector
Unit No. 01 Simmerly Slough	Right	7.65	10/27/2016 10/27/2016	Sterling York

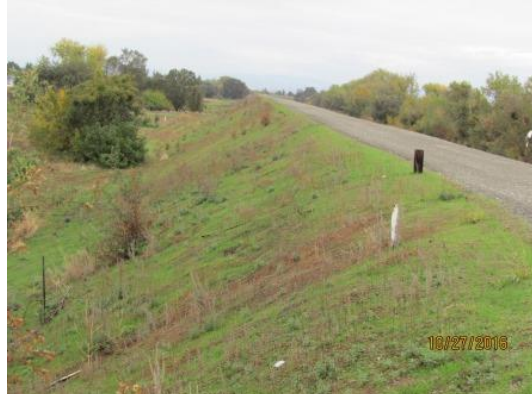
Photo 1 of 1 : FA\_2016\_RD0010\_163\_29\_20161031\_00069.jpg

LM Start	0.01	Rating **	A	Issue No.	29
LM End	7.62	Issue Type +	Ma	Location *	LS
Category	Earthen Levee			GPS Latitude/Longitude	
				Start	End
Item	Vegetation			39.163691 °	39.255746 °
				-121.609742 °	-121.574985 °
DWR ID	DWR_RD0010_01_f_2016_29				
Comment Code					
V1 : Control annual grass and weeds on the levee slopes and easements.					
Inspector Comment					
Annual vegetation is well maintained. Fall 2016.

View of well maintained annual vegetation on the landside looking upstream. Fall 2016.

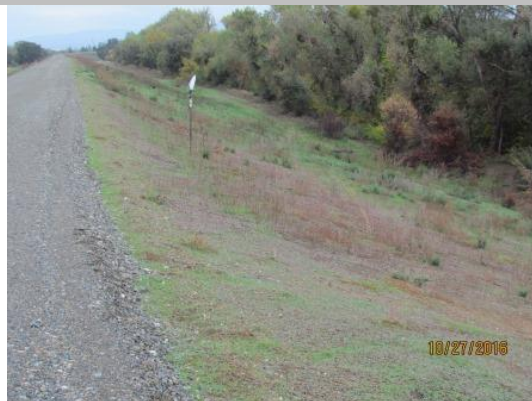
Photo 1 of 1 : FA\_2016\_RD0010\_163\_30\_20161031\_00070.jpg

LM Start	0.01	Rating **	A	Issue No.	30
LM End	7.62	Issue Type +	Ma	Location *	WS
Category	Earthen Levee			GPS Latitude/Longitude	
				Start	End
Item	Vegetation			39.163690 °	39.255746 °
				-121.609742 °	-121.574985 °
DWR ID	DWR_RD0010_01_f_2016_30				
Comment Code					
V1 : Control annual grass and weeds on the levee slopes and easements.					
Inspector Comment					
Annual vegetation is well maintained. Fall 2016.

View of well maintained annual vegetation on the waterside looking upstream. Fall 2016.

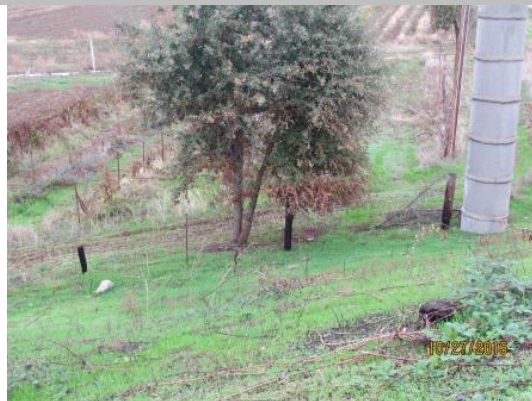
Photo 1 of 1 : FA\_2016\_RD0010\_163\_2\_20161031\_00071.jpg

LM Start	1.36	Rating **	A	Issue No.	2
LM End	1.36	Issue Type +	Ma	Location *	LS
Category	Earthen Levee			GPS Latitude/Longitude	
				Start	End
Item	Trim / Thin Trees			39.168769 °	39.168769 °
				-121.590409 °	-121.590409 °
DWR ID	DWR_RD0010_01_s_2016_2				
Comment Code					
T1 : Trim trees to at least five feet above ground level.					
Inspector Comment					
Tree limbs have been trimmed up for visibility and access. Fall 2016.

View of tree that has been trimmed up for visibility and access on the landside. Fall 2016.

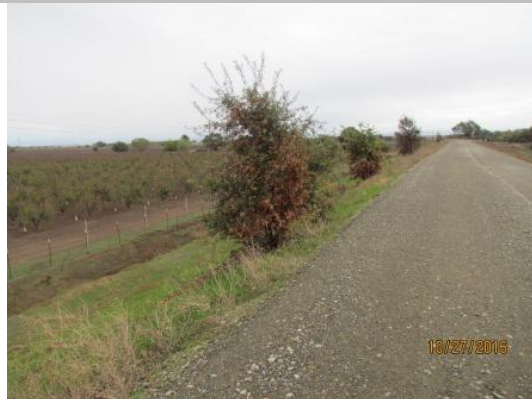
Photo 1 of 1 : FA\_2016\_RD0010\_163\_67\_20161031\_00072.jpg

LM Start	1.49	Rating **	M	Issue No.	67
LM End	1.52	Issue Type +	Ma	Location *	LS
Category	Earthen Levee			GPS Latitude/Longitude	
				Start	End
Item	Trim / Thin Trees			39.169221 °	39.169238 °
				-121.588073 °	-121.587550 °
DWR ID	DWR_RD0010_01_s_2016_67				
Comment Code					
T3 : Trim and thin trees to allow visibility of the ground and room to flood fight.					
Inspector Comment					
Small starter tree should be removed. Fall 2016.

View of a small tree that needs to be removed on the land side slope looking upstream. Fall 2016.

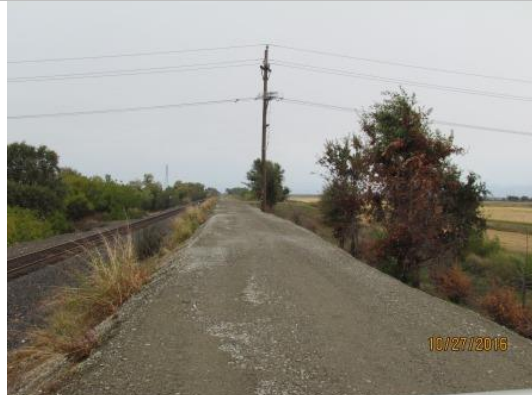
Photo 1 of 1 : FA\_2016\_RD0010\_163\_66\_20161031\_00073.jpg

LM Start	1.64	Rating **	M	Issue No.	66
LM End	1.64	Issue Type +	Ma	Location *	WS
Category	Earthen Levee			GPS Latitude/Longitude	
				Start	End
Item	Trim / Thin Trees			39.169721°	39.169721°
				-121.585759°	-121.585759°
DWR ID	DWR_RD0010_01_s_2016_66				
Comment Code					
T1 : Trim trees to at least five feet above ground level.					
Inspector Comment					
Small trees should be trimmed up for visibility and access. Fall 2016.

View of a small tree that needs to be trimmed for visibility and access on the land side slope looking upstream. Fall 2016.

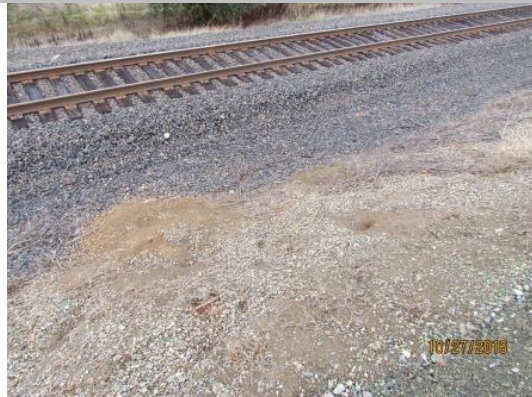
Photo 1 of 1 : FA\_2016\_RD0010\_163\_65\_20161031\_00074.jpg

LM Start	1.75	Rating **	M	Issue No.	65
LM End	1.75	Issue Type +	Ma	Location *	LS
Category	Earthen Levee			GPS Latitude/Longitude	
				Start	End
Item	Animal Control			39.171200 °	39.171200 °
				-121.585576 °	-121.585576 °
DWR ID	DWR_RD0010_01_s_2016_65				
Comment Code					
A3 : No rodents visible, but rodent burrows visible; need to backfill and compact or grout burrows.					
Inspector Comment					
Squirrel hole still are visible but no sign of activity, Fall 2016.

View of squirrel holes on the landside, no rodent activity was observed. Fall 2016.

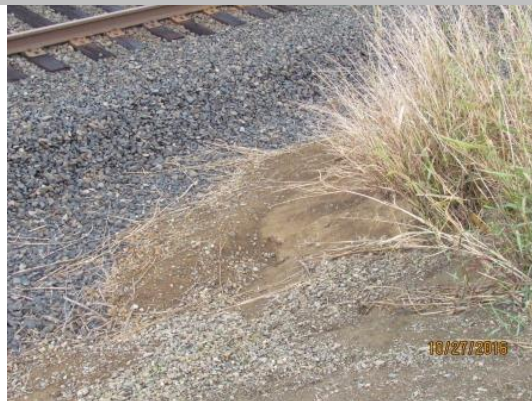
Photo 1 of 1 : FA\_2016\_RD0010\_163\_64\_20161031\_00075.jpg

View of squirrel holes on the landside, no rodent activity was observed. Fall 2016.

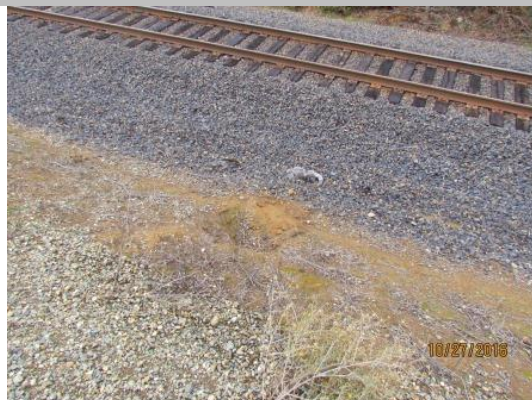
Photo 1 of 1 : FA\_2016\_RD0010\_163\_63\_20161031\_00076.jpg

LM Start	2.09	Rating **	M	Issue No.	63
LM End	2.09	Issue Type +	Ma	Location *	LS
Category	Earthen Levee			GPS Latitude/Longitude	
				Start	End
Item	Animal Control			39.176153 °	39.176153 °
				-121.584958 °	-121.584958 °
DWR ID	DWR_RD0010_01_s_2016_63				
Comment Code					
A3 : No rodents visible, but rodent burrows visible; need to backfill and compact or grout burrows.					
Inspector Comment					
Squirrel hole still are visible but no sign of activity, Fall 2016.

View of squirrel holes on the landside, no rodent activity was observed. Fall 2016.

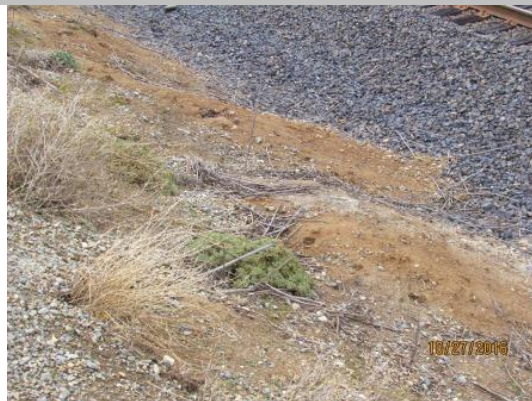
Photo 1 of 1 : FA\_2016\_RD0010\_163\_61\_20161031\_00077.jpg

View of squirrel holes on the landside slope and toe, no rodent activity was observed. Fall 2016.

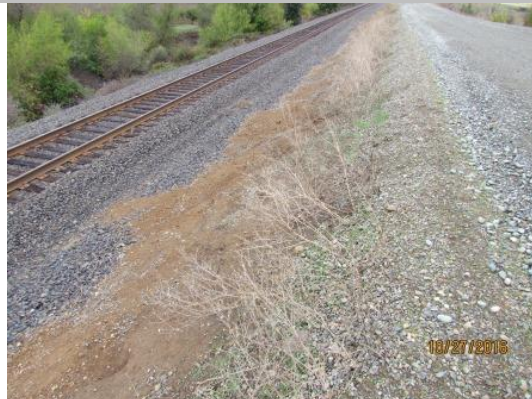
Photo 1 of 1 : FA\_2016\_RD0010\_163\_60\_20161031\_00078.jpg

LM Start	2.56	Rating **	M	Issue No.	60
LM End	2.61	Issue Type +	Ma	Location *	LS
Category	Earthen Levee			GPS Latitude/Longitude	
				Start	End
Item	Animal Control			39.182940 °	39.183721 °
				-121.584115 °	-121.584019 °
DWR ID	DWR_RD0010_01_s_2016_60				
Comment Code					
A3 : No rodents visible, but rodent burrows visible; need to backfill and compact or grout burrows.					
Inspector Comment					
Squirrel hole still are visible but no sign of activity, Fall 2016.

View of squirrel holes on the landside slope and toe, no rodent activity was observed. Fall 2016.

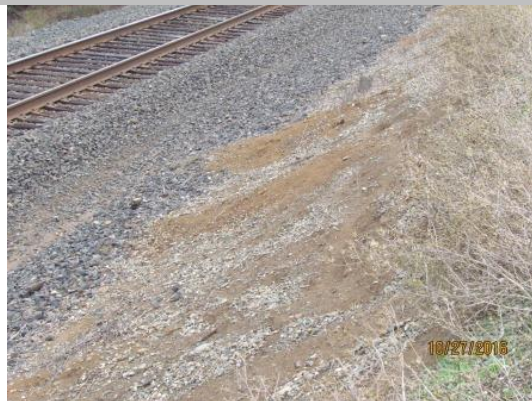
Photo 1 of 1 : FA\_2016\_RD0010\_163\_59\_20161031\_00079.jpg

View of squirrel holes on the landside slope and toe, no rodent activity was observed. Fall 2016.

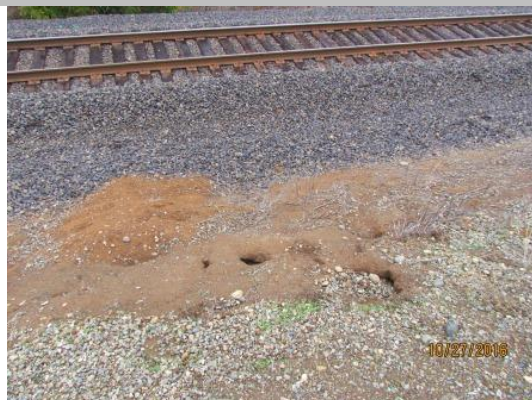
Photo 1 of 1 : FA\_2016\_RD0010\_163\_58\_20161031\_00080.jpg

LM Start	2.67	Rating **	M	Issue No.	58
LM End	2.67	Issue Type +	Ma	Location *	LS
Category	Earthen Levee			GPS Latitude/Longitude	
				Start	End
Item	Animal Control			39.184513 °	39.184513 °
				-121.583924 °	-121.583924 °
DWR ID	DWR_RD0010_01_s_2016_58				
Comment Code					
A3 : No rodents visible, but rodent burrows visible; need to backfill and compact or grout burrows.					
Inspector Comment					
Squirrel hole still are visible but no sign of activity, Fall 2016.

View of squirrel holes on the landside slope and toe, no rodent activity was observed. Fall 2016.

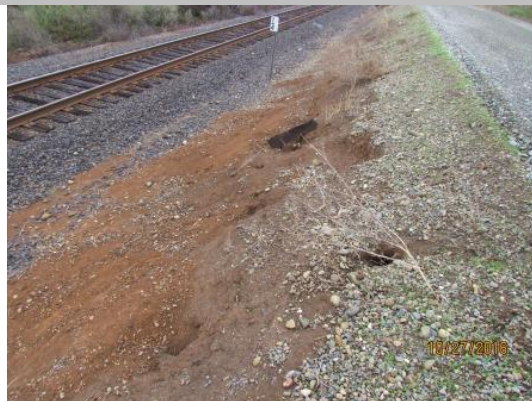
Photo 1 of 1 : FA\_2016\_RD0010\_163\_57\_20161031\_00081.jpg

View of squirrel holes on the landside slope and toe, no rodent activity was observed. Fall 2016.

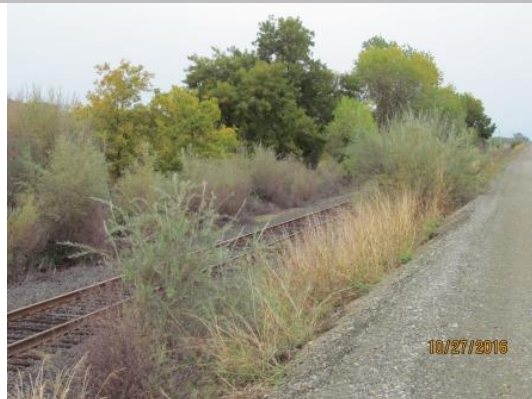
Photo 1 of 1 : FA\_2016\_RD0010\_163\_55\_20161031\_00082.jpg

LM Start	3.01	Rating **	M	Issue No.	55
LM End	3.01	Issue Type +	Ma	Location *	LS
Category	Earthen Levee			GPS Latitude/Longitude	
				Start	End
Item	Trim / Thin Trees			39.189497°	39.189497°
				-121.583308°	-121.583308°
DWR ID	DWR_RD0010_01_s_2016_55				
Comment Code					
T3 : Trim and thin trees to allow visibility of the ground and room to flood fight.					
Inspector Comment					
Small willow tree on landside slope should be removed. Fall 2016.

View of small willow trees on the landside slope looking upstream. Fall 2016.

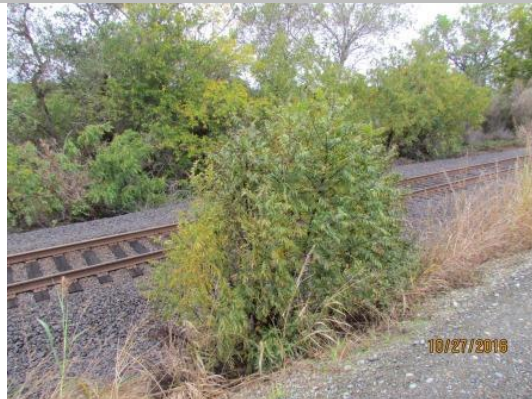
Photo 1 of 1 : FA\_2016\_RD0010\_163\_54\_20161031\_00083.jpg

View of small willow trees on the landside toe looking upstream. Fall 2016.

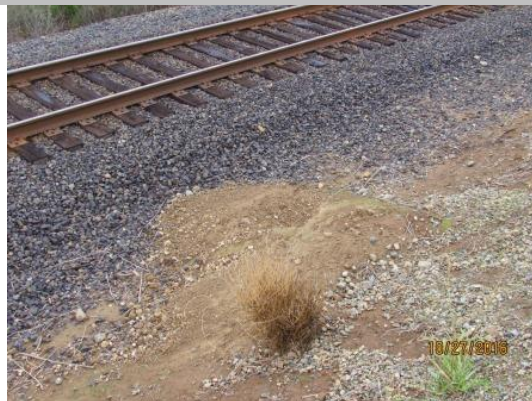
Photo 1 of 1 : FA\_2016\_RD0010\_163\_52\_20161031\_00085.jpg

View of squirrel holes on the landside slope and toe, no rodent activity was observed. Fall 2016.

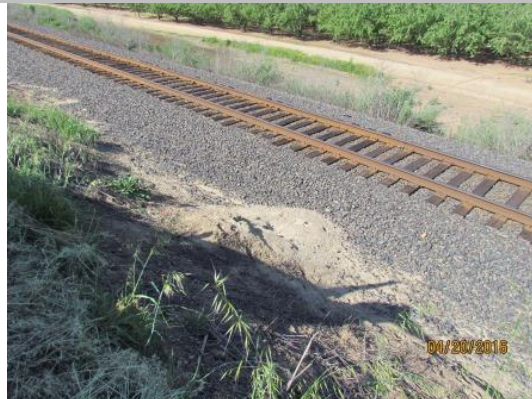
Photo 1 of 1 : FA\_2016\_RD0010\_163\_51\_20160906\_00017.jpg

View of large burrow on landside.

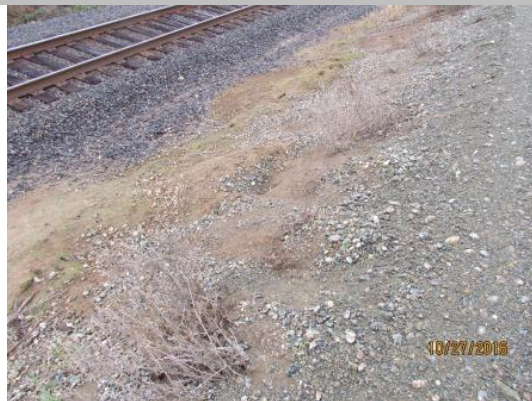
Photo 1 of 1 : FA\_2016\_RD0010\_163\_50\_20161031\_00086.jpg

View of squirrel holes on the landside slope and toe, no rodent activity was observed. Fall 2016.

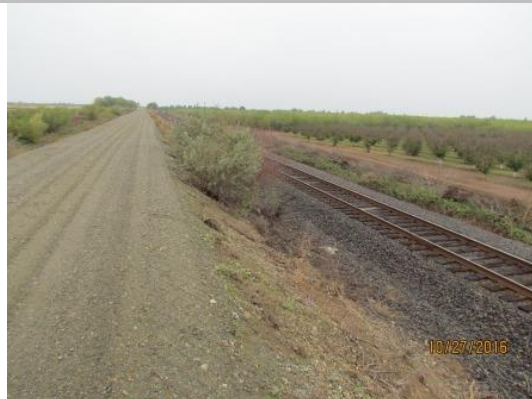
Photo 1 of 1 : FA\_2016\_RD0010\_163\_47\_20161031\_00087.jpg

View of a small willow tree that should be removed on the landside looking down stream. Fall 2016.

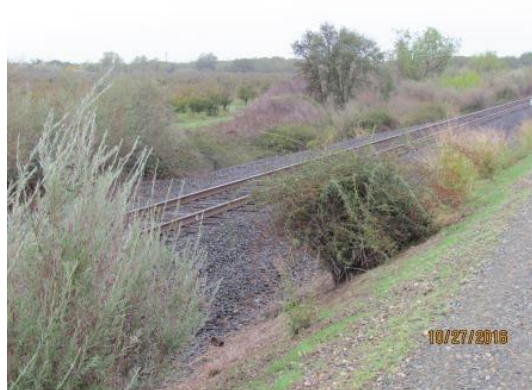
Photo 1 of 1 : FA\_2016\_RD0010\_163\_45\_20161031\_00090.jpg

View of wild rosebush on the landside levee slope looking upstream. Fall 2016.

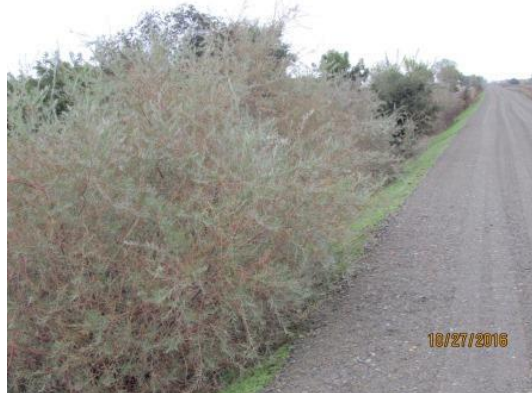
Photo 1 of 1 : FA\_2016\_RD0010\_163\_40\_20161031\_00092.jpg

View of willow trees on the landside slope looking upstream. Fall 2016.

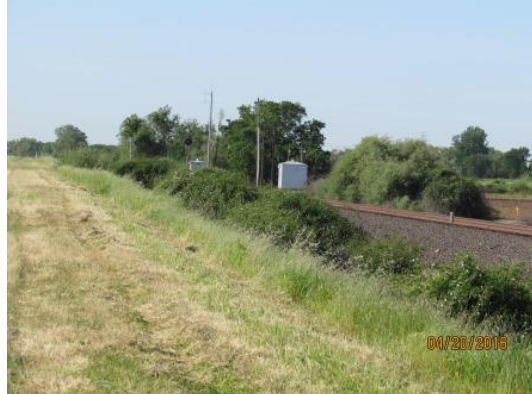
Photo 1 of 2 : FA\_2016\_RD0010\_163\_36\_20160906\_00013.jpg

View looking downstream landside of wild rosebushes that are blocking visibility at the toe. Spring 2016.

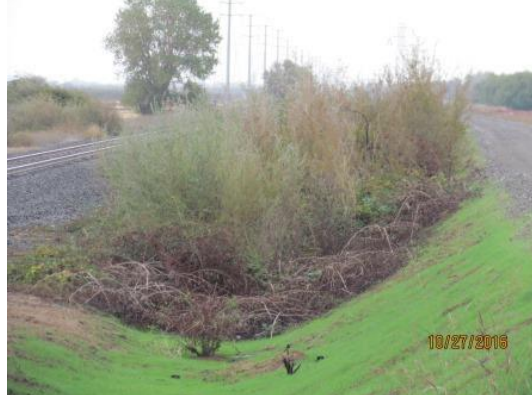
Photo 2 of 2 : FA\_2016\_RD0010\_163\_36\_20161031\_00093.jpg

View looking upstream landside of willows and wild rosebushes that are blocking visibility at the toe. Fall 2016.

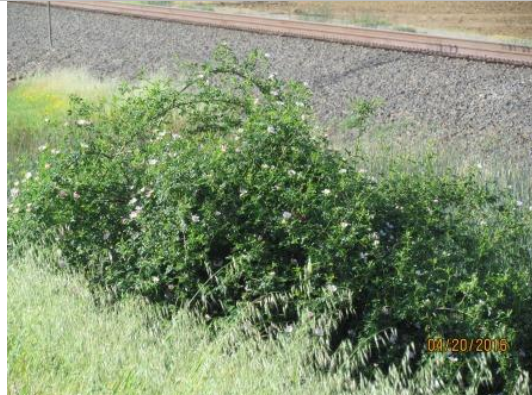
Photo 1 of 1 : FA\_2016\_RD0010\_163\_34\_20160906\_00012.jpg

View of thick wild rose bush that obstructs visibility of the landside slope and toe. Spring 2016.

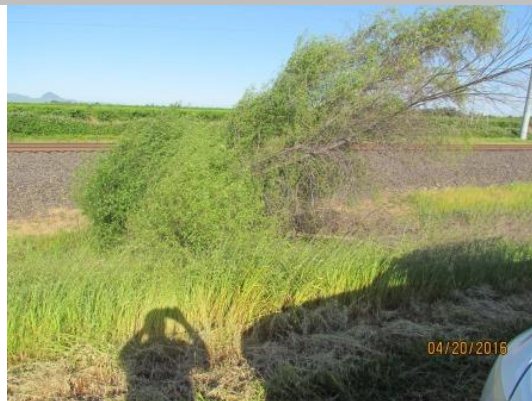
Photo 1 of 2 : FA\_2016\_RD0010\_163\_32\_20160906\_00011.jpg

View of a tree that needs to be removed. Small trees 4" in diameter at chest height should be removed before they get to big. View of landside. Spring 2016.

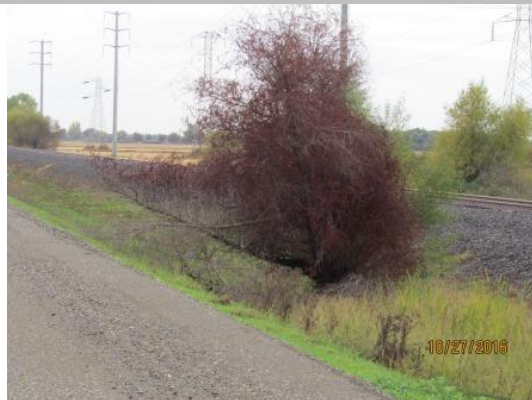
Photo 2 of 2 : FA\_2016\_RD0010\_163\_32\_20161031\_00096.jpg

View of a tree that needs to be removed on the landside, looking downstream. Fall 2016.

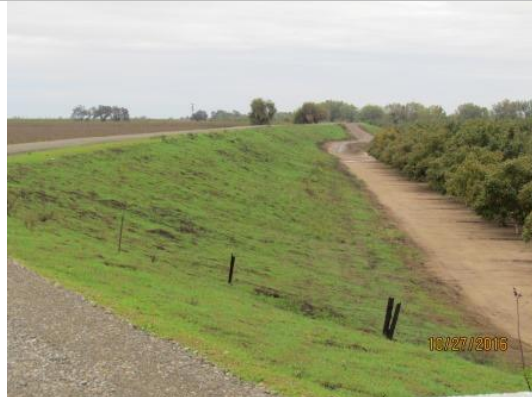
Photo 1 of 1 : FA\_2016\_RD0010\_164\_48\_20161031\_00068.jpg

View of well maintained annual vegetation on the waterside looking downstream. Fall 2016.

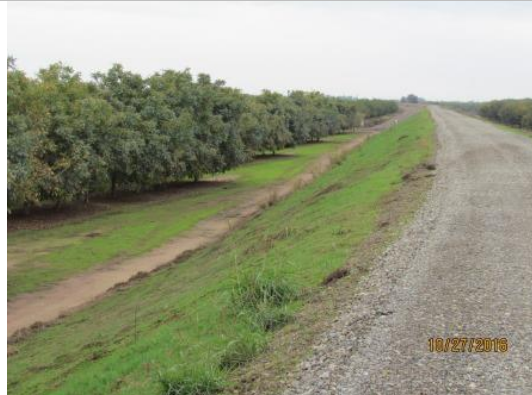
Photo 1 of 1 : FA\_2016\_RD0010\_164\_24\_20161031\_00069.jpg

View of well maintained annual vegetation on the landside looking downstream. Fall 2016.

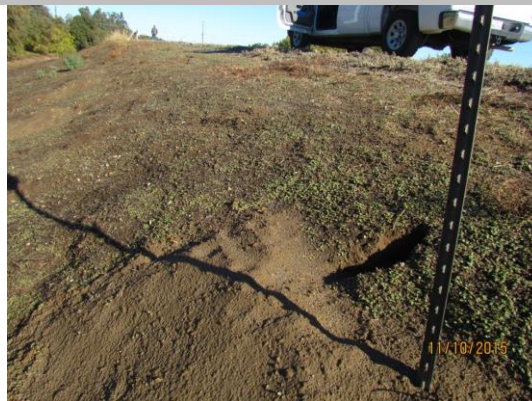
Photo 1 of 2 : FA\_2016\_RD0010\_164\_28\_20160906\_00007.jpg

View of the rodent hole on the waterward side of the levee looking upstream. Fall 2015.

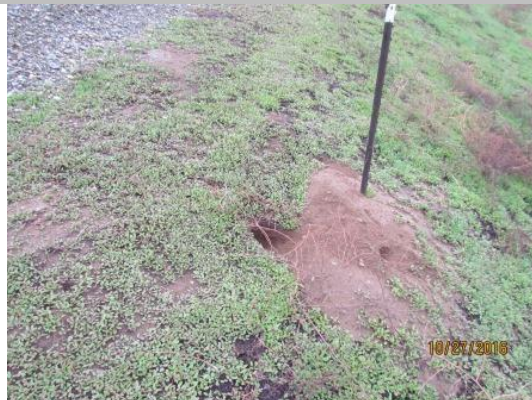
Photo 2 of 2 : FA\_2016\_RD0010\_164\_28\_20161031\_00070.jpg

View of squirrel hole on the waterside looking downstream. Fall 2016

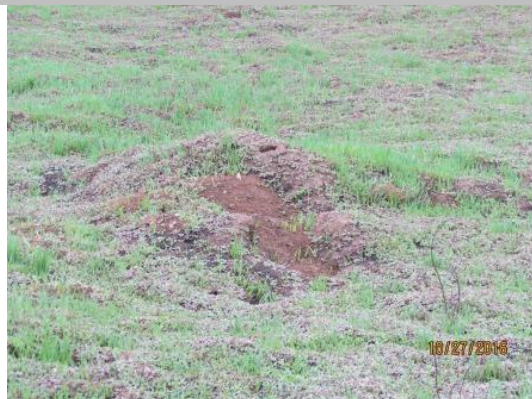
Photo 1 of 1 : FA\_2016\_RD0010\_164\_29\_20161031\_00072.jpg

View of rodent hole that has more than 2 cubic feet of material on the waterside. Fall 2016.

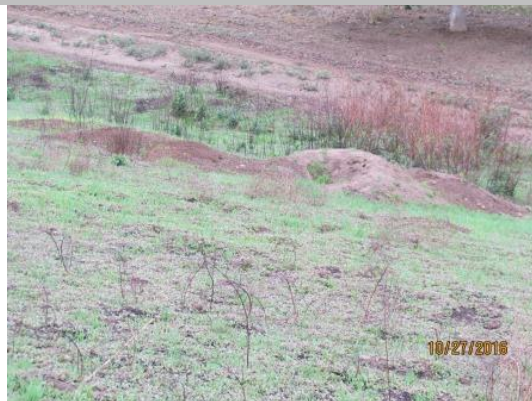
Photo 1 of 1 : FA\_2016\_RD0010\_164\_30\_20161031\_00073.jpg

View of rodent hole on waterside levee slope. Fall 2016.

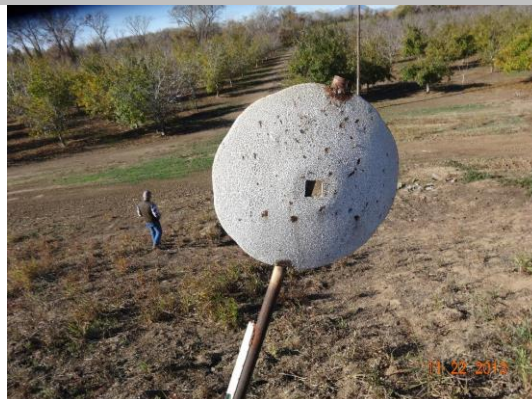
Photo 1 of 3 : FA\_2016\_RD0010\_164\_7\_20160906\_00001.jpg

Marker visible on waterward side.

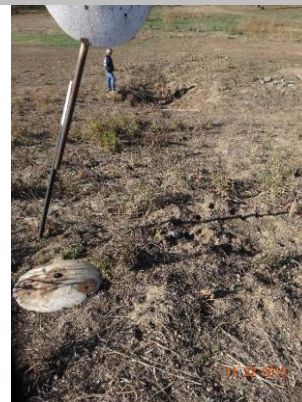
Photo 2 of 3 : FA\_2016\_RD0010\_164\_7\_20160906\_00002.jpg

View of waterward slope--burrow activity present.

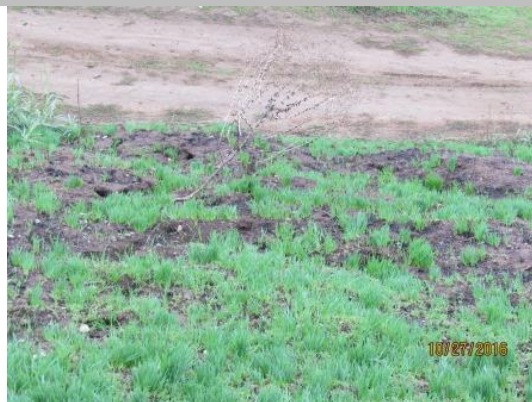
Photo 1 of 1 : FA\_2016\_RD0010\_164\_68\_20161031\_00079.jpg

View of rodent holes on waterside slope. Fall 2016.

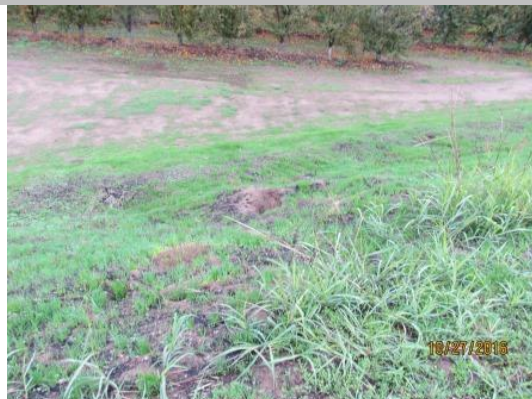
Photo 1 of 1 : FA\_2016\_RD0010\_164\_50\_20161031\_00087.jpg

View of rodent hole on landside slope. Fall 2016.

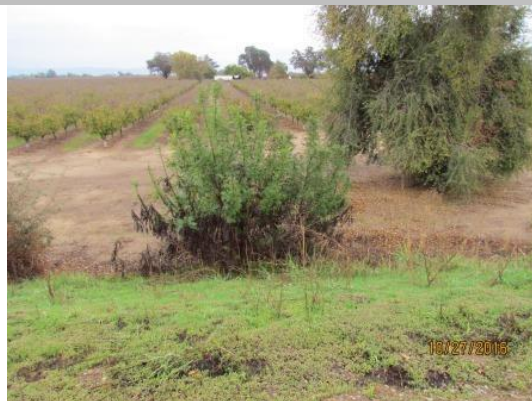
Photo 1 of 1 : FA\_2016\_RD0010\_164\_47\_20161031\_00088.jpg

View of a small tree at the toe of the landside. Fall 2016.

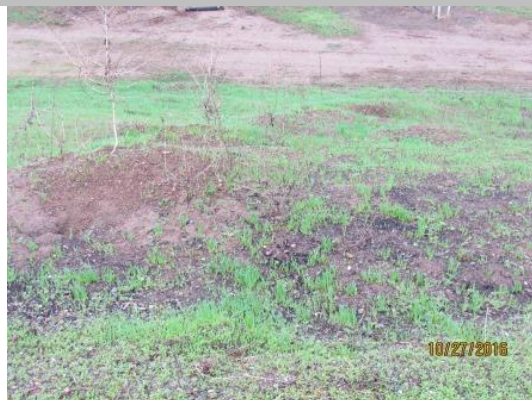
Photo 1 of 1 : FA\_2016\_RD0010\_164\_32\_20161031\_00092.jpg

View of rodent holes on waterside levee slope. Fall 2016.

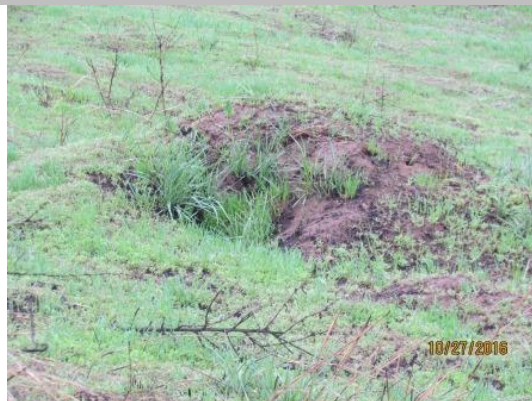
Photo 1 of 1 : FA\_2016\_RD0010\_164\_33\_20161031\_00094.jpg

View of rodent hole that has more than 2 cubic feet of material, this hole is not active but needs to be backfilled properly. Fall 2016.

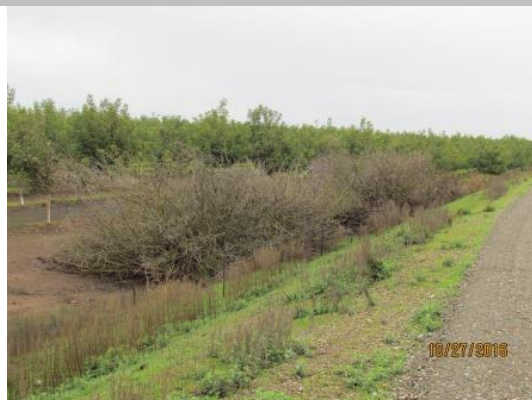
Photo 1 of 1 : FA\_2016\_RD0010\_164\_56\_20161102\_00100.jpg

View of small willows at landside levee toe looking downstream. Fall 2016.

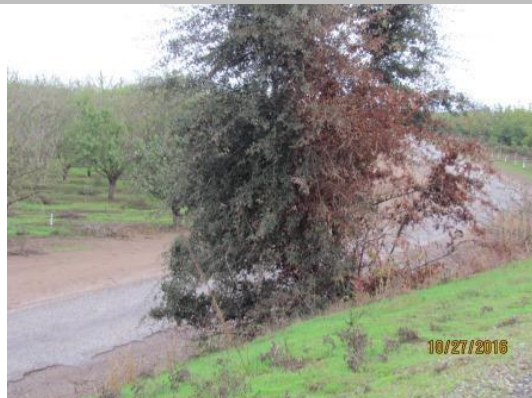
Photo 1 of 1 : FA\_2016\_RD0010\_164\_59\_20161102\_00104.jpg

View of a tree on landside looking downstream that needs to be trimmed up 5' for access and visibility. Fall 2016.

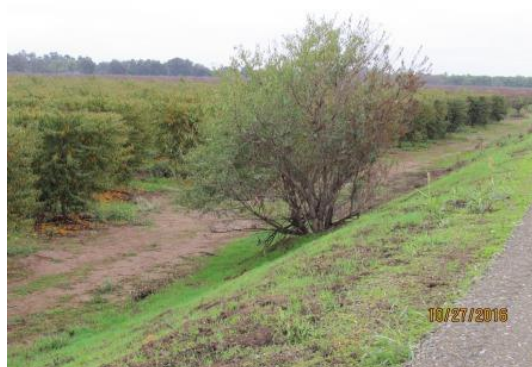
Photo 1 of 1 : FA\_2016\_RD0010\_164\_66\_20161103\_00109.jpg

View of small willow tree on the landside toe looking downstream that should be removed. Fall 2016.

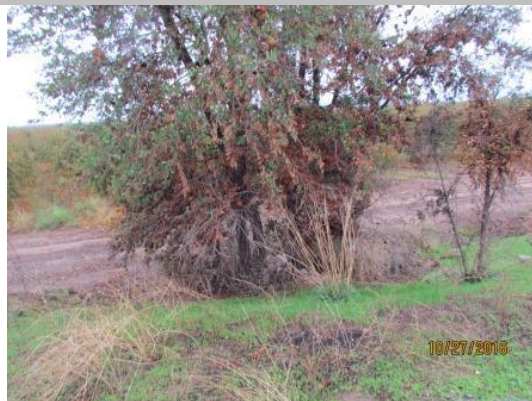
Photo 1 of 1 : FA\_2016\_RD0010\_164\_70\_20161103\_00114.jpg

View of tree on landside toe that need to be trimmed up five feet for visibility and access. Fall 2016.

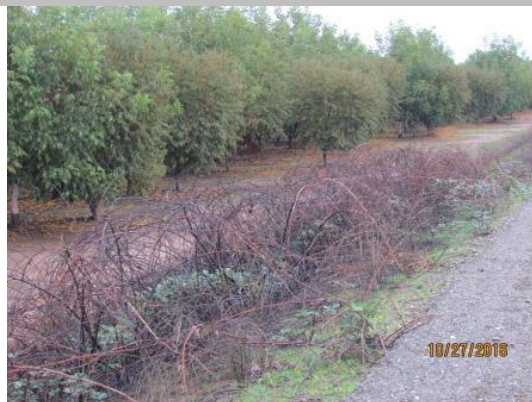
Photo 1 of 1 : FA\_2016\_RD0010\_164\_72\_20161103\_00116.jpg

LM Start	9.95	Rating **	M	Issue No.	72
LM End	10.30	Issue Type +	Ma	Location *	LS
Category	Earthen Levee			GPS Latitude/Longitude	
				Start	End
Item	Vegetation			39.293740°	39.296901°
				-121.607210°	-121.612145°
DWR ID	DWR_RD0010_02_s_2016_72				
Comment Code					
V2 : Remove the wild growth other than native grasses from the levee slopes.					
Inspector Comment					
Blackberry bushes have been sprayed/burned, but need to removed. Fall 2016.

View of landside looking downstream at Blackberry bushes that have been sprayed/burned, but need to removed. Fall 2016.

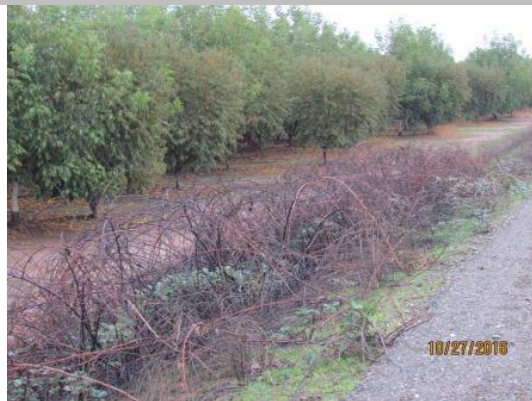
Photo 1 of 1 : FA\_2016\_RD0010\_164\_73\_20161103\_00117.jpg

View of landside slope looking downstream where blackberry bushes have been sprayed and burned but need to be removed. Fall 2016.

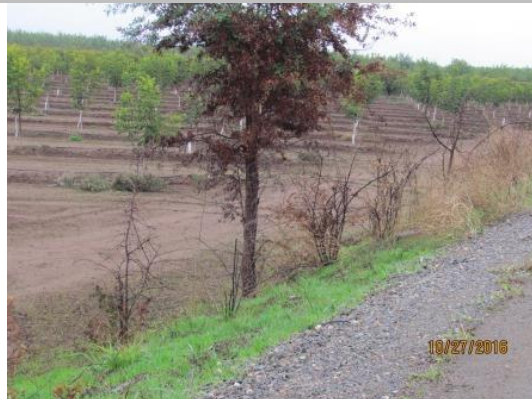
Photo 1 of 1 : FA\_2016\_RD0010\_164\_75\_20161103\_00118.jpg

View of landside looking downstream where the tree has been trimmed up but small starter trees should be removed. Fall 2016.

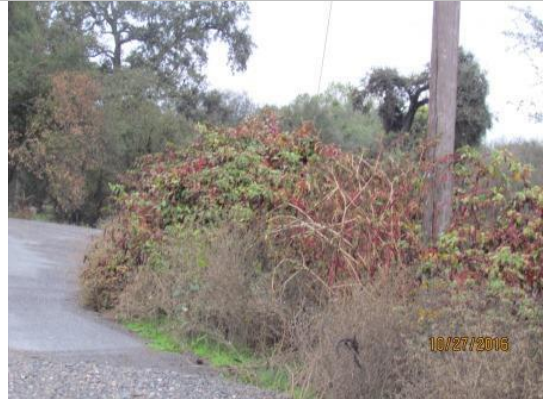
Photo 1 of 1 : FA\_2016\_RD0010\_164\_76\_20161103\_00119.jpg

View looking downstream at wild growth on waterside slope that needs to be removed. Fall 2016.

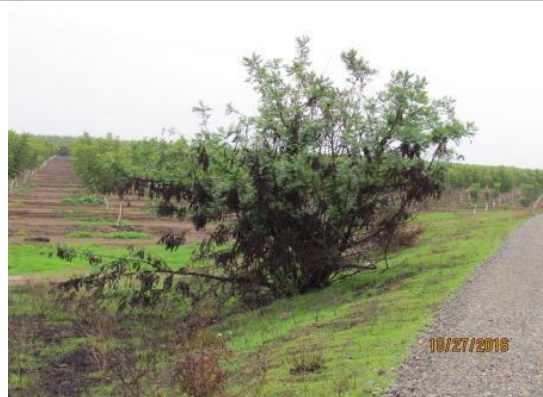
Photo 1 of 1 : FA\_2016\_RD0010\_164\_77\_20161103\_00120.jpg

View looking downstream of a small tree on landside slope that should be removed. Fall 2016.

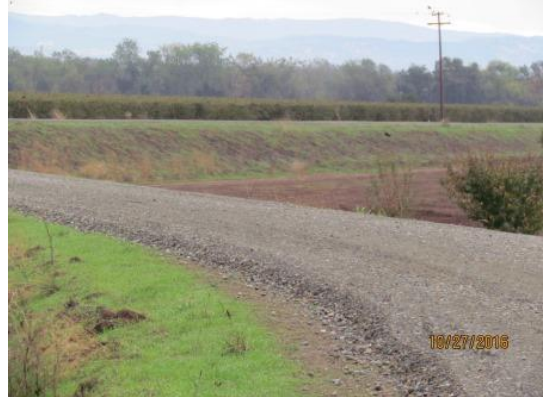
Photo 1 of 1 : FA\_2016\_RD0010\_165\_4\_20161103\_00011.jpg

View of the well maintained vegetation on the waterside looking downstream. Fall 2016.

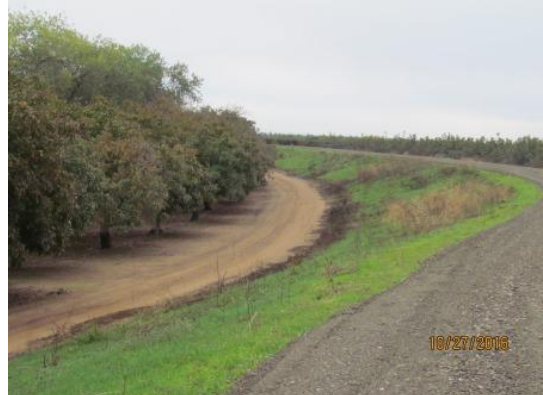
Photo 1 of 1 : FA\_2016\_RD0010\_165\_5\_20161103\_00010.jpg

View of the well maintained vegetation on the landside looking downstream. Fall 2016.

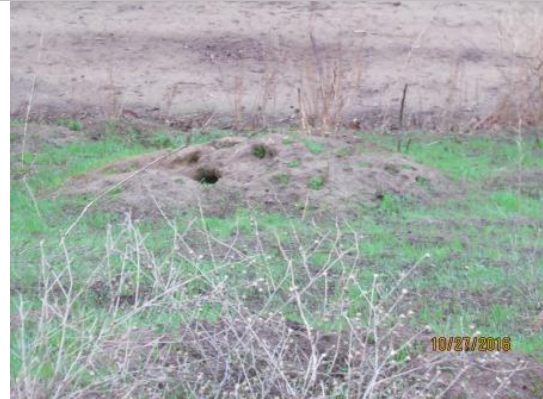
Photo 1 of 1 : FA\_2016\_RD0010\_165\_6\_20161103\_00015.jpg

View of waterside slope, no squirrel activity seen, but rodent holes need to be back filled properly. Fall 2016.
